**2019**

**Lower Neches River Basin &  
Neches-Trinity Coastal Basin**

**BASIN HIGHLIGHTS REPORT**

**PREPARED BY LOWER NECHES VALLEY AUTHORITY IN COOPERATION WITH THE  
TEXAS COMMISSION ON ENVIRONMENTAL QUALITY**

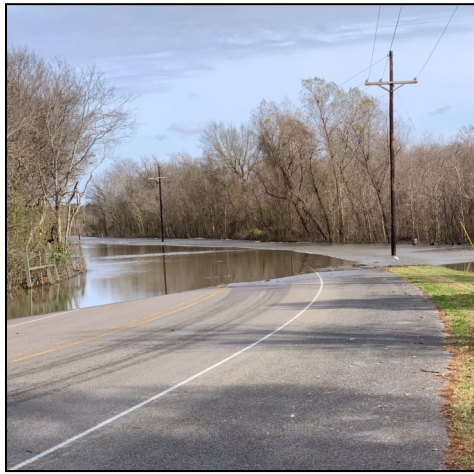
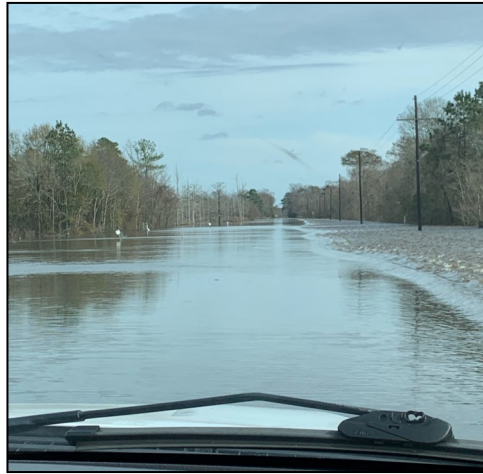
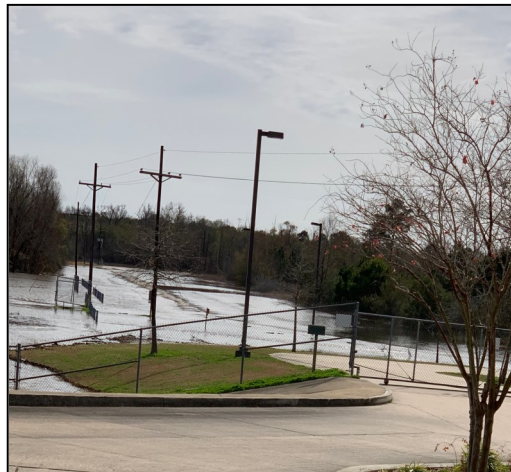
**The three pictures above show the water over the access road at the Saltwater Barrier on the Neches River in early January 2019.**

Due to heavy rainfall north of the lower Neches Basin during the month of January 2019, the Neches River, as well as Pine Island Bayou, experienced flood conditions. According to USGS site 08041780-gage height data, the Neches River at the Saltwater Barrier crested January 8, 2019 at 8.46 feet. Anytime the Neches River elevation at the Salt Water Barrier exceeds 4.0 feet, the barrier is considered to be operating in flood mode. If the river elevation gets to 6.5 feet, the City of Beaumont is notified that the access road to the barrier is forecast to be flooded and the road is then closed to the public. During the first couple of weeks of January, LNVA staff were able to get to the Saltwater Barrier in LNVA fleet trucks. There have been times in previous flood conditions that staff has had to come in by boat. Pine Island Bayou near Sour Lake reaches flood stage at 25 feet. During this event in early January, the flood stage averaged around 27 feet. Pine Island Bayou above the BI Pumping Plant reaches flood stage at 11 feet. It crested at 11.9 feet during this January event.

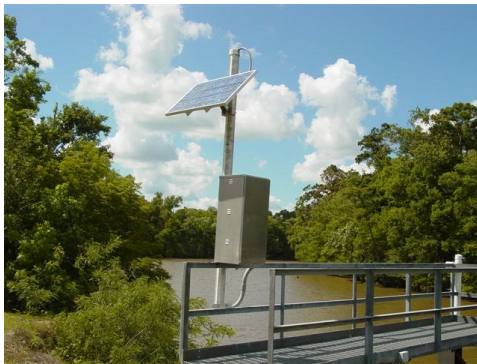
In June 2008, TCEQ, in cooperation with LNVA, installed a Continuous Water Quality Monitoring Network (CWQMN) station on Pine Island Bayou near the Hwy 69 bridge at LNVA's BI canal pump station. LNVA proposed the real-time monitoring station in 2006 to address water quality concerns in Pine Island Bayou. LNVA operates and maintains the station (CAMS 749), which uses YSI Instruments equipped with multiple probes including optical dissolved oxygen and turbidity. The station collects and transmits real-time data for the following parameters:

dissolved oxygen, pH, water temperature, conductivity, total dissolved solids, turbidity, and water depth. Pine Island Bayou CWQMN Station (CAMS 749) displays real-time water quality data online at the following:

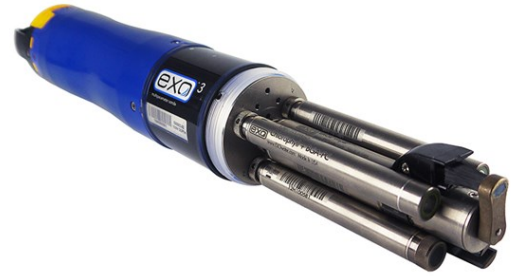
In December 2018, the TCEQ provided LNVA with a new multi-probe sonde and display unit for use in CAMS 749 monitoring activities. The new YSI EXO-3 sonde is capable of measuring depth, pH, temperature, dissolved oxygen, conductivity, and turbidity. The new equipment allows for reduced ongoing maintenance costs, better data storage/transfer/management capabilities, and faster response times.
