2021

Texas Clean Rivers Program Basin Summary Report

Lower Neches Basin and
Neches-Trinity Coastal Basin

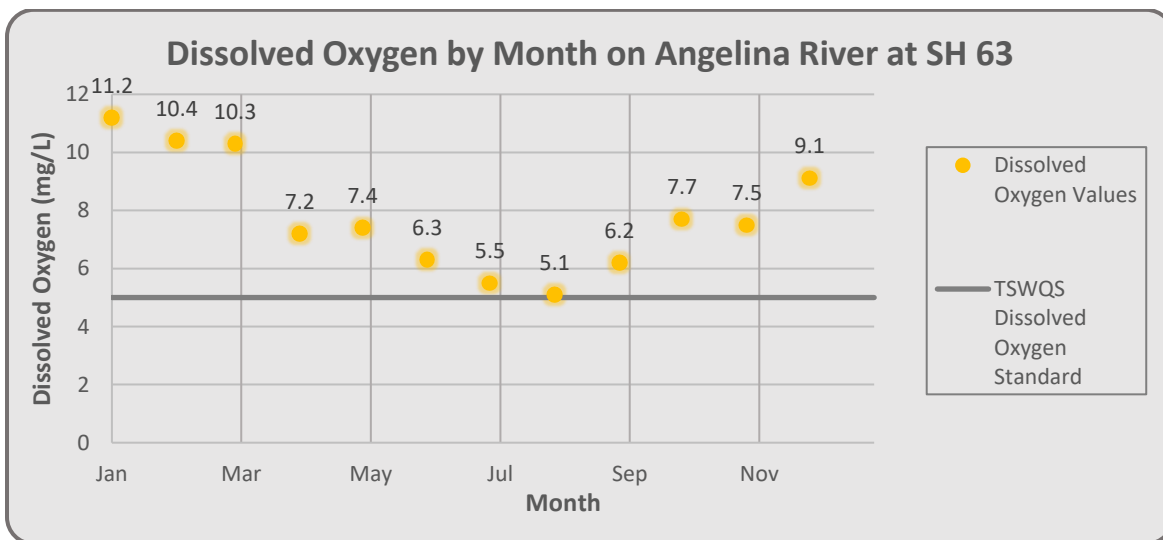
Figure 3.11 Monthly Dissolved Oxygen on the Angelina River

Due to the releases from Sam Rayburn Reservoir, dissolved oxygen concentrations peak during winter months while lower concentrations occur during summer months when the reservoir is stratified. During summer lake stratification, colder water sinks to the bottom while the warmer waters rise to the surface. At this time circulation is limited to the upper lake level, and the colder water near the bottom is depleted of oxygen. The situation is reversed during the winter when the entire water column is at or near the same temperature; therefore, allowing full circulation and replenishment of oxygen. Figures 3.11 and 3.12 demonstrate how the average dissolved oxygen is affected by the time of year and ambient temperature.

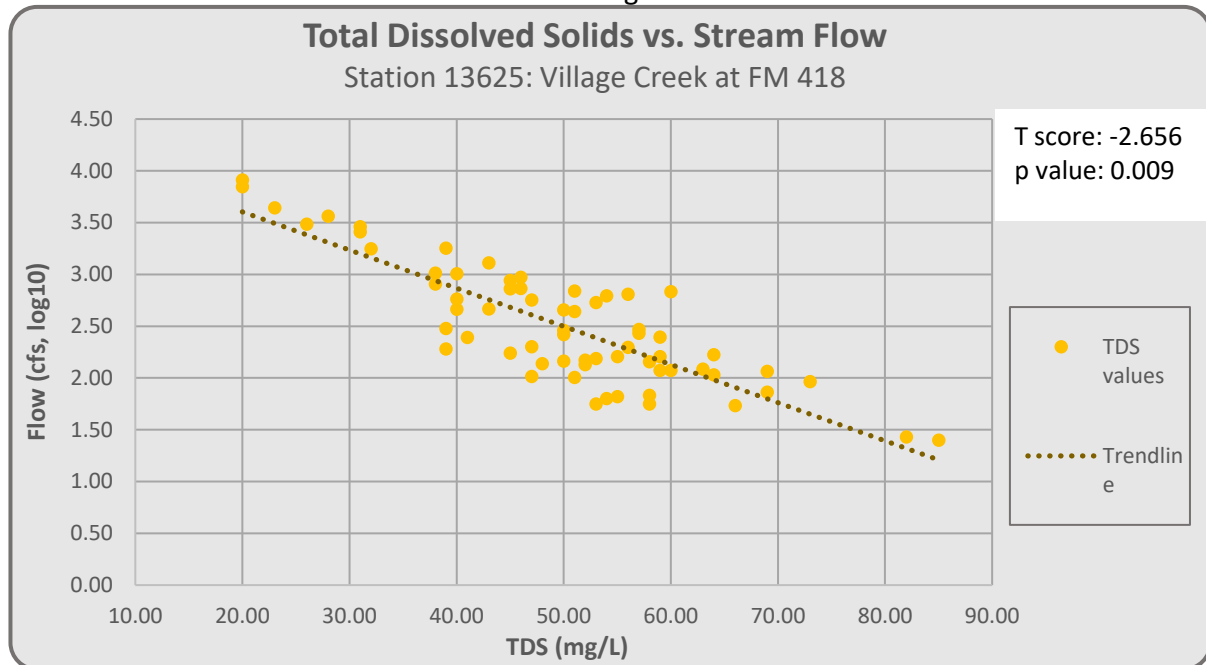
Figure 3.30 TDS Versus Stream Flow in Village Creek at FM 418

Total dissolved solids (TDS) at this site can be attributed to periods of drought followed by intense rainfall. TDS refers to any salts, minerals, metals, cations, or anions dissolved in water. Increased levels of TDS can be attributed to runoff and non-point wastewater discharges. Highly dissolved solids can affect the permeability of ions and aquatic organisms. As shown in Figure 3.30, TDS levels have exhibited an increasing trend over time. The average TDS concentration is 51 mg/L, well below the stream standard of 300 mg/L. Pulse flow events replace portions of the water column with unsaturated water and can result in lower TDS values. Adversely in periods of decreased flow, TDS increases as shown in Figure 3.31. TDS values begin to decrease after 2014 which suggests the increase over time was due to the extended drought.

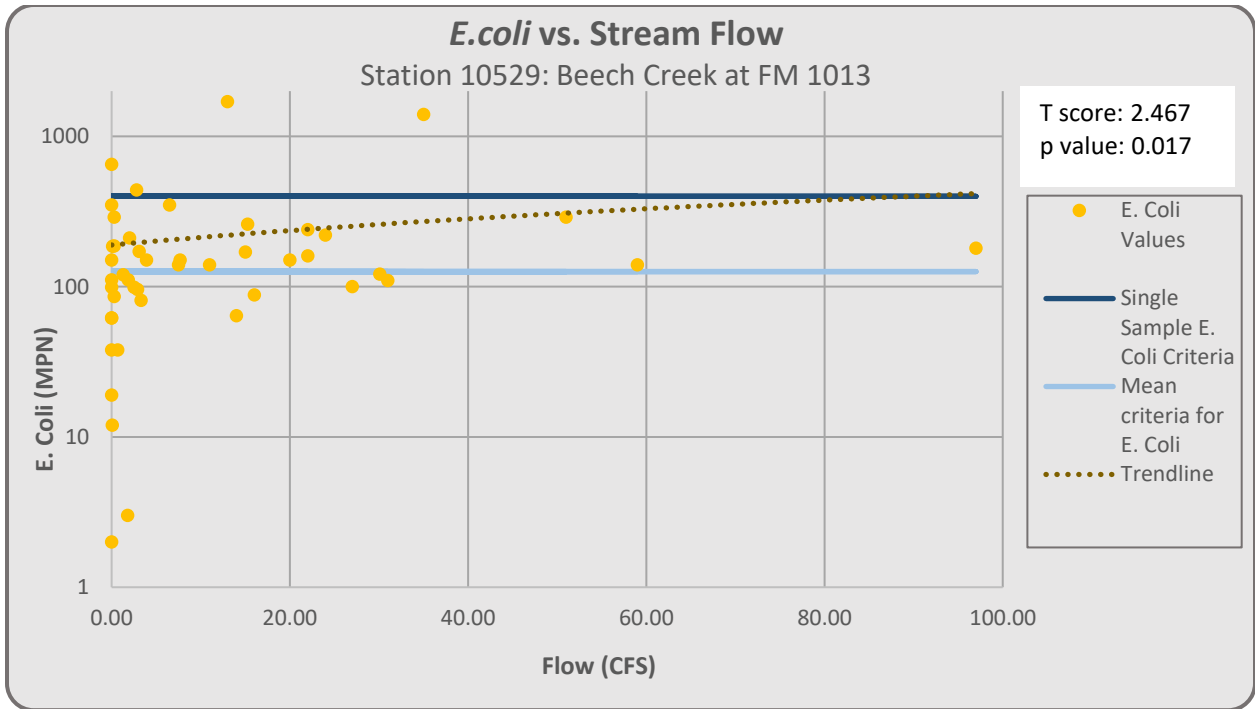
Figure 3.35 *E.coli* Versus Stream Flow in Beech Creek

There is a correlation between stream flow and *E.coli* bacteria levels, as shown in Figure 3.35. Timing of *E.coli* sampling with runoff from rainfall is crucial when comparing flow with bacteria levels. The cause of the bacteria concern in Beech Creek is thought to be from nonpoint source origins such as livestock runoff or wildlife waste. Bacteria levels as a whole have remained consistent over time, as shown in Figure 3.36. The steam standard for *E.coli* is 126 indicator bacteria per 100mL.

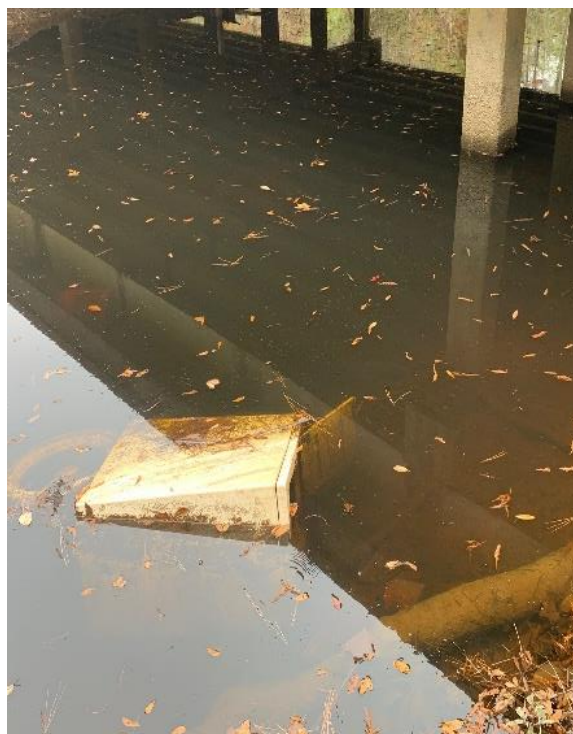
Figure 3.37 Washing Machine Discarded in Beech Creek

Another concern for Beech Creek is habitat. The source of this concern is thought to be nonpoint sources, livestock and wild animals. In order to get further information about this stream in regards to whether or not its meeting its designated high aquatic life use, the LNVA contracted a water monitoring company to conduct aquatic life monitoring on Beech Creek in 2019 and 2020. One sampling event will carry over into 2021 due to delays from weather events. The average DO for Beech Creek is 6.4 mg/L, which is above the stream standard of 5 mg/L. More information about aquatic life monitoring for Beech Creek will continue in segment 0608C Cypress Creek. One issue LNVA staff has noticed at the Beech Creek sampling station is its a popular spot for trash dumping. This trash ranges from household garbage and food wrappers to large appliances, as shown in Figure 3.34 The remote bridge location over FM 1013 has provided the opportunity for littering. In the future, the LNVA hopes to organize cleanup days at this site and others like it.

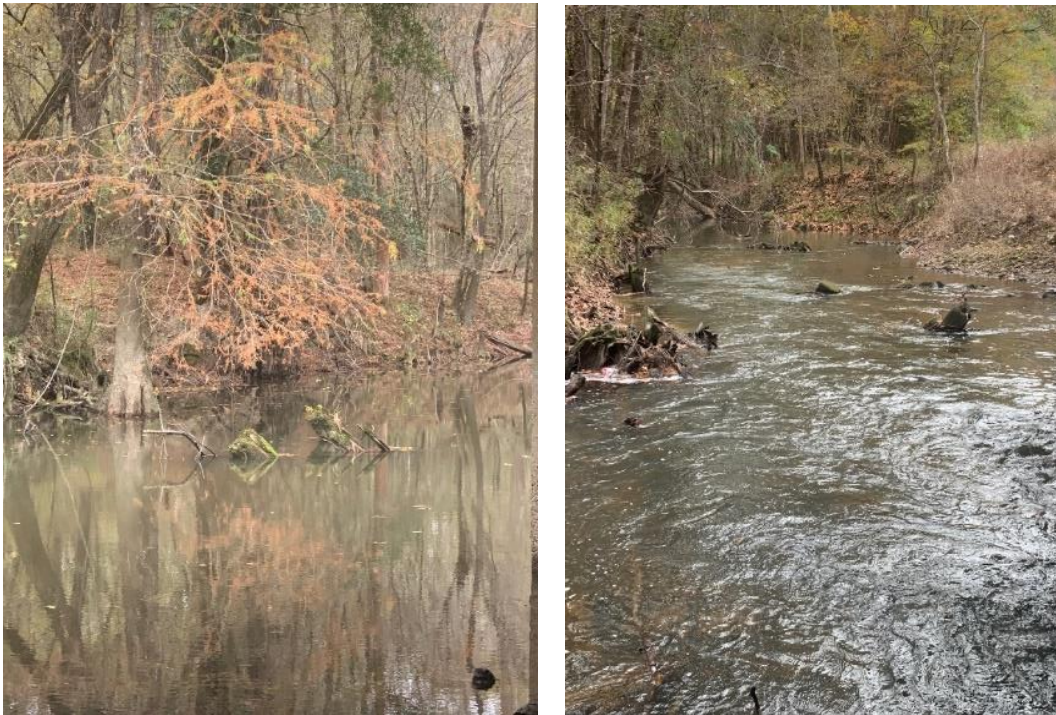
Figure 3.45 Station #15349: Hickory Creek Upstream (left) and Downstream (right)

The LNVA monitors Hickory @ 69, Station #15349, which is not listed on the 2020 Texas Integrated Report for any concerns or impairments. There were no significant trends found during LNVA's data assessment. Hickory Creek demonstrates stream bed variation with deeper wider channels upstream and narrowing channels with more downstream as shown in Figure 3.45.

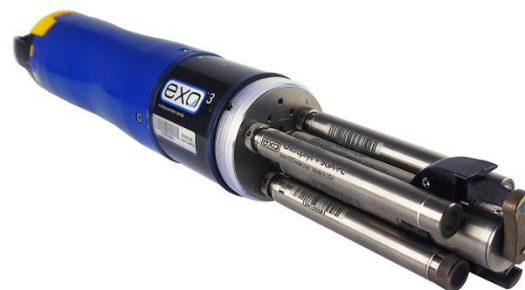
Figure 3.59 The EXO is the YSI instrument used to monitor CWQMN station CAMS749

The water quality data at CAMS749 is collected using a YSI multiprobe instrument, as show in in Figure 3.54. The LNVA cleans and maintains the site and calibrates the YSI multiprobe on a monthly basis. In addition, CAMS749 provides LNVA municipal/industrial customers with near real-time data about raw water pumped from PIB into LNVA’s canal system. Customers are able to react 2-4 days in advance of raw water entering their facilities, allowing appropriate operational adjustments based on changing water quality parameters. In addition, information from this site is used for engineering and design of new facilities and budgeting purposes. The LNVA is also collecting 24 HR dissolved oxygen at several stations where special monitoring has been assigned.

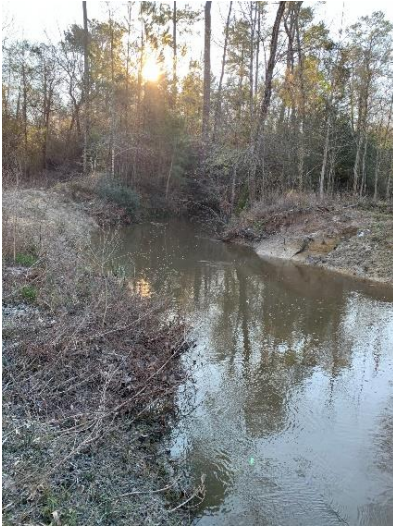
Figure 3.65 Station #16127: Boggy Creek

Station #13127, located on the small tributary Boggy Creek connecting to PIB, is monitored by TCEQ. The station is 1.09 miles southwest of FM 421 and US 69 intersection near Lumberton. Boggy Creek is listed in the 2020 Texas Integrated Report for habitat impairment, recreational use concern for *E. coli*, and nonsupport of aquatic life due to depressed dissolved oxygen. Boggy Creek exhibits similar dissolved oxygen characteristics as other portions of PIB. Monitoring data indicates Boggy Creek may also meet the new dissolved oxygen standard level of 3.0 mg/L as shown in Figure 3.66. The data shows increasing levels of dissolved oxygen during the indicated timeframe; however, the site was dropped in 2004, causing a data gap, until being picked up again in 2013 by TCEQ. To contribute additional data to the regular quarterly monitoring conducted by TCEQ, the LNVA began conducting quarterly 24-hour dissolved oxygen collections on Boggy Creek

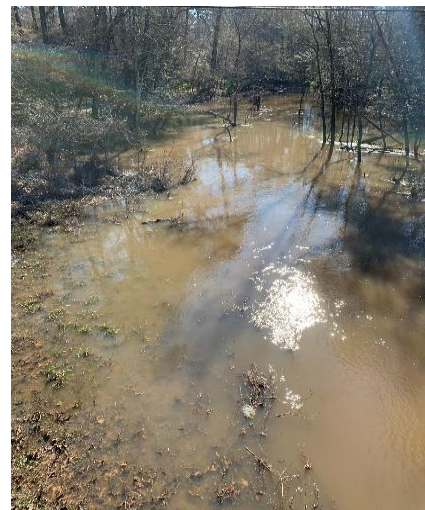
Figure 3.68 Station 15346: Little Pine Island Bayou at SH 326

Little Pine Island Bayou (LPIB), like PIB and Boggy Creek, is listed in the 2020 Texas Integrated report for not supporting aquatic life due to depressed dissolved oxygen levels. The LNVA routinely monitors one site on Little Pine Island Bayou located on South Highway 326 in Sour Lake, Station #15346, as shown in Figure 3.68. Along with regular monitoring, 24-hour dissolved oxygen events were conducted quarterly by the LNVA in fiscal year 2020. This additional sampling may provide supporting evidence that LPIB is also reaching attainment with the 2018 TSWQS dissolved oxygen standard of 3.0 mg/L as shown in Figure 3.69.

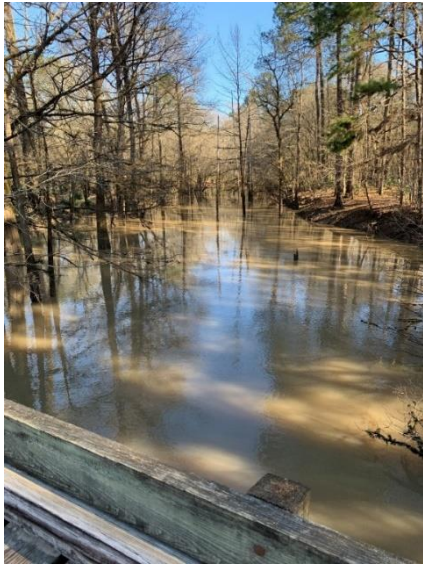
Figure 3.71 Station #15345: Willow Creek

There is currently only one site being routinely monitored on Willow Creek by the LNVA, Station #15345, as shown in Figure 3.71. Continued sampling will be required in order to provide TCEQ with enough data to assess whether Willow Creek is meeting the current standard for dissolved oxygen.
