**2018**

***BASIN HIGHLIGHTS REPORT***

*Lower Neches River Basin &  
Neches-Trinity Coastal Basin*

**Lower Neches Valley Authority**

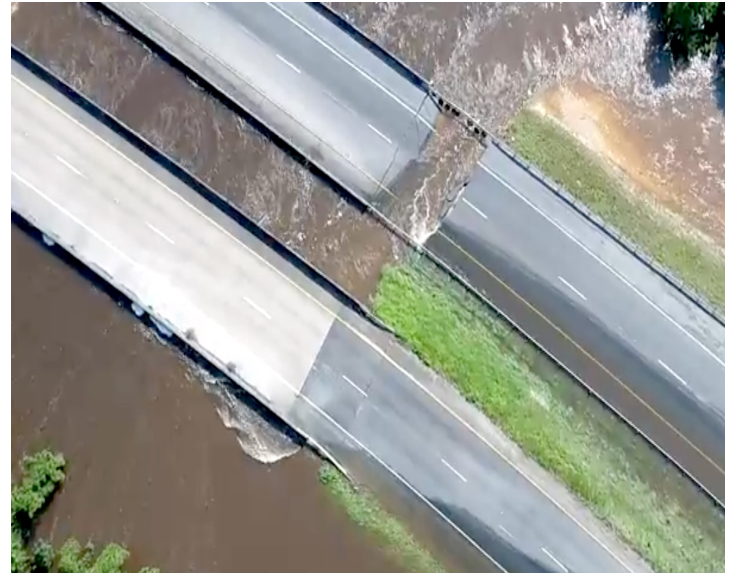
*Bridge approach washout on Hwy 96 near Village Creek .*

After Harvey, it took almost a week in some areas for the flood waters to recede. Many major roadways remained impassable. This included a portion of Highway 96 were it approaches Village Creek between Lumberton and Silsbee. (pictured above). A section of the highway collapsed due to erosion caused by the flood waters. The City of Beaumont lost its primary and secondary sources of drinking water and citizens were required to boil water for several weeks. As of October 2017, FEMA approved a total of 372,973 Individual Assistance Applications. The dollar amount for individual and household programs was \$1,611,230,889.61. Total Public Assistance Grant dollars obligated were \$644,247,219.86. Both dollar amounts are as of October 2017 as well. These totals don't include the homeowners or business owners that had flood insurance and did not qualify for assistance from FEMA. There are still people that are displaced from their homes or in the process of trying to rebuild their homes. In the interim period between infrastructures stabilizing, LNVA staff were able to help with demolition work on some of the homes in the community. This involved removing personal belongings, appliances, cutting out sheet rock, pulling out carpet and cabinets, and removing furniture that had come in contact with the flood waters. It only takes a few days for mold to begin to grow once flood waters have receded and since many were unable to get in their homes for up to a week, very little was salvageable depending on the water depth. As a result of so many homes and businesses affected by the flooding, the streets in the area were lined with debris

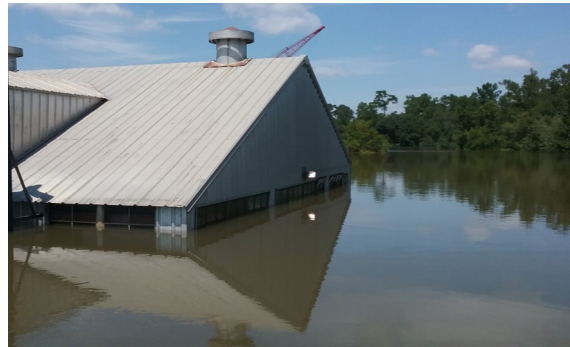
*LNVA Neches 1st Pumping Station flooded by the Neches River.*

Several of LNVA's facilities were significantly impacted by the flood waters of Hurricane Harvey. One of these facilities was the main pumping station responsible for getting water from the Neches River to water customers. Once the flood waters receded, staff worked around the clock to make to make sure this plant was operational when the need for water from industry and municipalities came. The Saltwater Barrier facility that is home base for LNVA's water quality lab and the Clean Rivers Program (CRP) was also affected heavily by water damage. The entire lab as well as the barrier office had to be torn out and rebuilt. Chemicals and equipment contaminated by the flood waters had to be disposed of and re-ordered. The CRP sampling planned for the quarter of September through November of 2017 was unable to be performed. CRP sampling began again in February 2018.

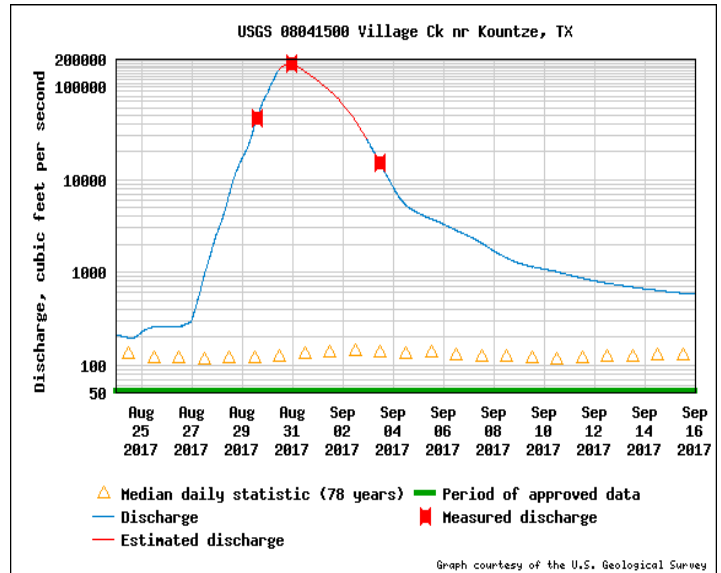
The graph below courtesy of the U.S Geological Survey (USGS) shows the water discharge in cubic feet per second on Village Creek during Hurricane Harvey. The discharge measured between August 30, 2017 through September 2, 2017 discharge values are estimated by USGS.

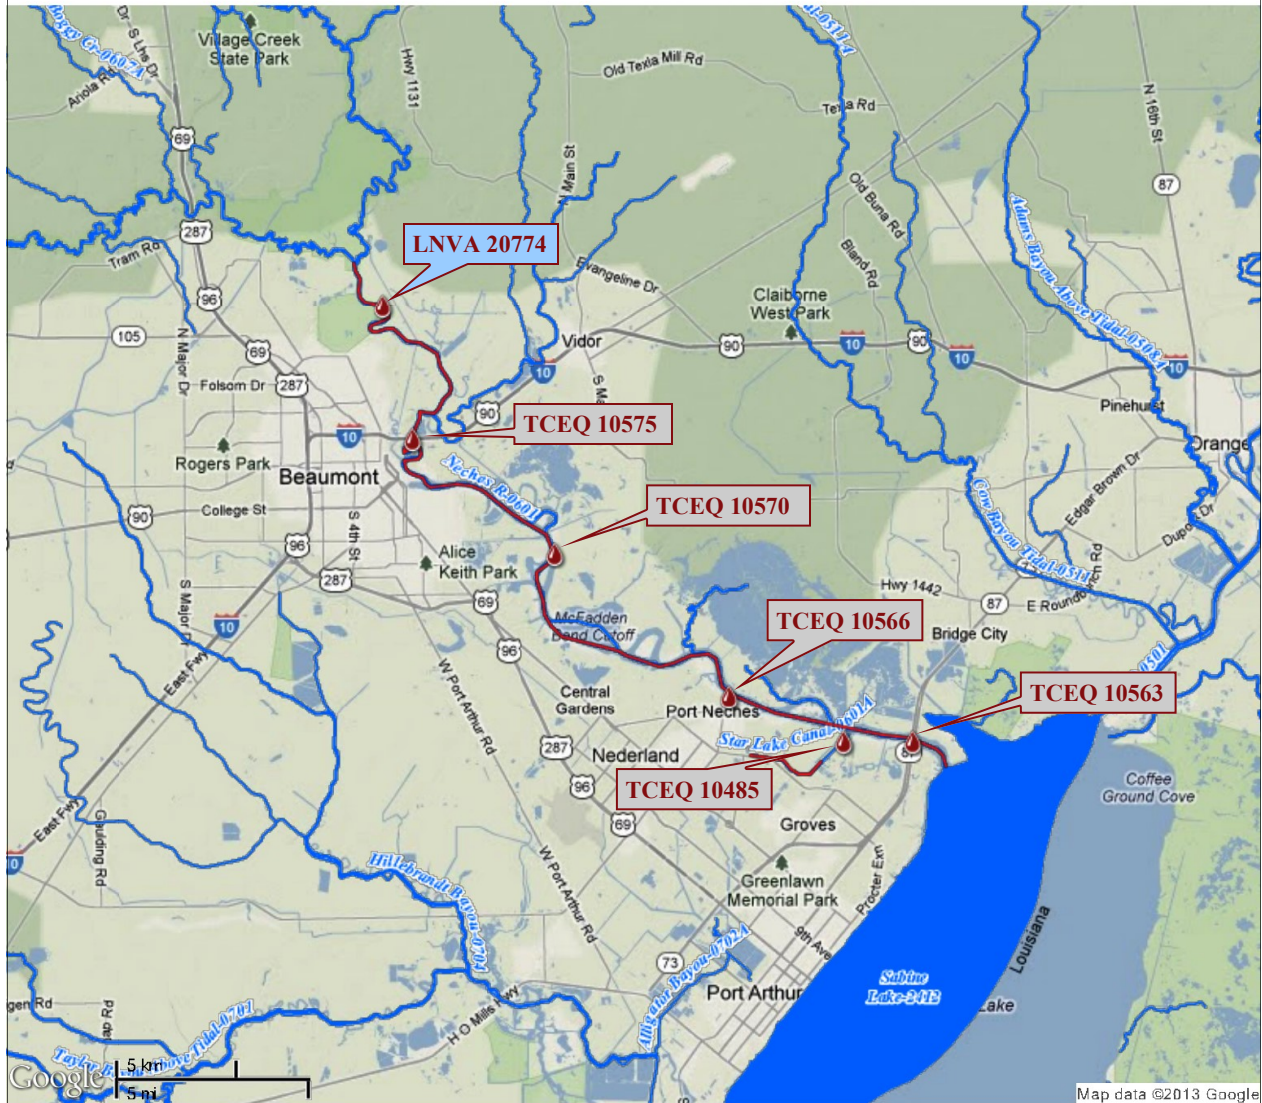
SEGMENT: 601 Neches River Tidal

Site Description	Station ID	Water-body ID	Basin	Agency	Field	Conv.	Bacteria	Flow	Metals in sediment
NECHES RIVER 0.8 KM DOWNSTREAM OF MOBIL CANAL 9.65 KM DOWNSTREAM OF IH 10 780 M UPSTREAM OF MANSFIELD FERRY ROAD	10570	0601	6	TCEO	4	4	4		4
NECHES RIVER AT LNVA SALINITY STATION Y 1.8 KILOMETERS DOWNSTREAM OF NECHES RIVER SALTWATER	20774	0601	6	LNVA	4	4	4	4	
NECHES RIVER AT PORT NECHES CITY PARK BOAT RAMP 117 M NORTHEAST OF MERRIMAN STREET IN BEAUMONT	10566	0601	6	TCEO	4	4	4		
NECHES RIVER AT SH 87 BRIDGE NORTH OF PORT	10563	0601	6	TCEO	4	4	4		4
NECHES RIVER BRIDGE AT IH 10 NEAR BEAUMONT 1.02 KM EAST OF US 90/IH 10 INTERSECTION	10575	0601	6	TCEO	4	4	4		4
STAR LAKE CANAL 0.4 KM UPSTREAM OF THE NECHES RIVER KM UPSTREAM OF SH 87/GULFWAY DRIVE NORTH OF PORT ARTHUR	10485	0601A	6	TCEO	4	4	4		4

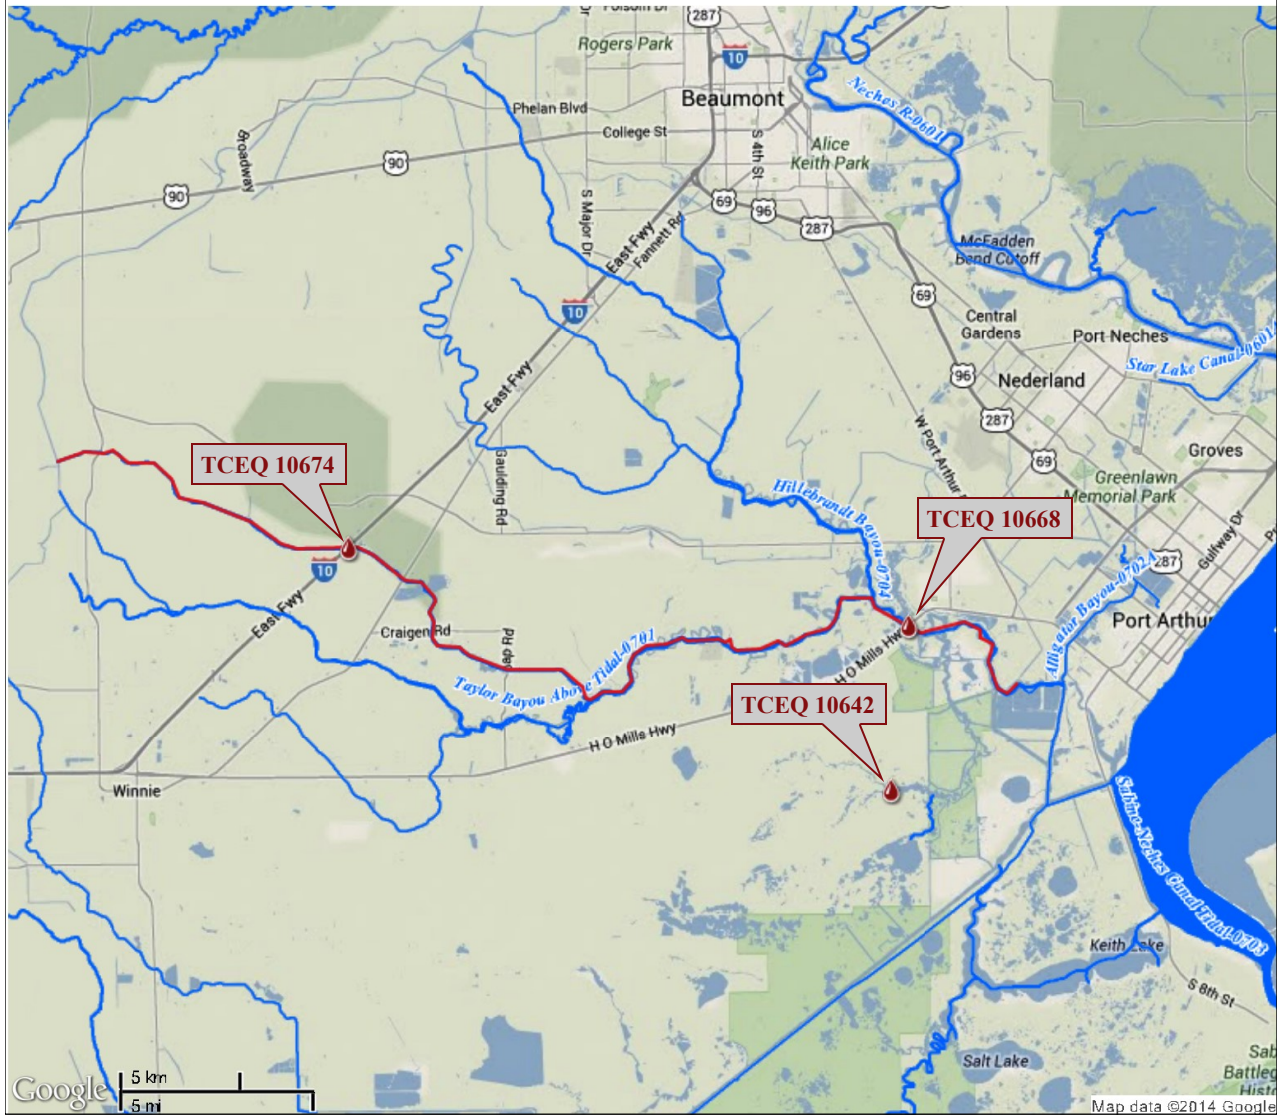
SEGMENT: 701 Taylor Bayou/North Fork Taylor Bayou Above Tidal

Site Description	Station ID	Waterbody ID	Basin	Agency	Field	Conv.	Bacteria	Metals in water
TAYLOR BAYOU AT SH 73 WEST OF PORT ARTHUR	10668	0701	7	TCEQ	4	4	4	
TAYLOR BAYOU NORTH FORK AT IH 10	10674	0701	7	TCEQ	4	4	4	
SHALLOW PRONG LAKE ON BIG HILL BAYOU WEST-ERNMOST ARM NEAR FENCE PILINGS	10642	0701D	7	TCEQ	4	4	4	4
