# **BASIN HIGHLIGHTS REPORT**

Lower Neches River Basin & Neches-Trinity Coastal Basin

**Lower Neches Valley Authority**

Prepared in cooperation with the Texas Commission on Environmental Quality under the authorization of the Texas Clean Rivers Act

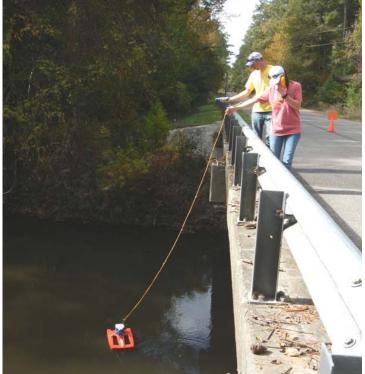
LNVA Environmental Analysts collect stream flow measurements at CRP routine monitoring stations using a Teledyne RD Instruments' StreamPro ADCP (Acoustic Doppler Current Profiler).

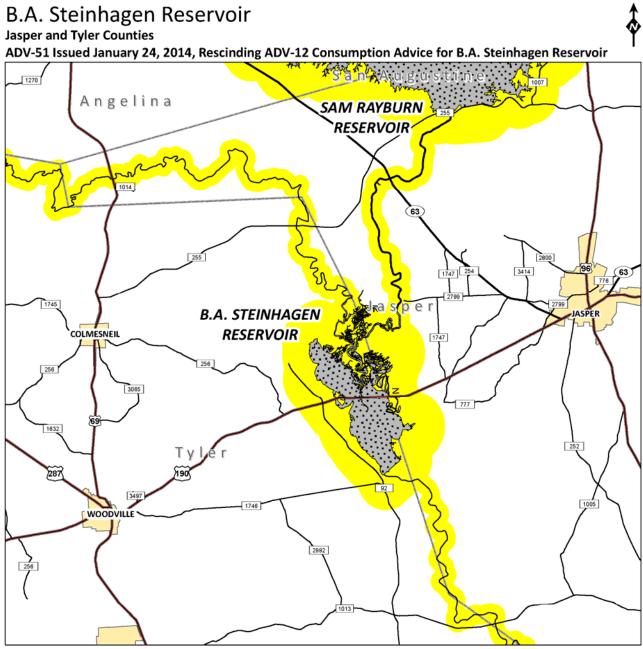
**Contaminants of Concern:** Dioxins and Mercury (Hg)

Species Affected	Women of Childbearing Age and Children < 12	Women Past Childbearing Age and Adult Men <sup>1</sup>				
Blue catfish > 30 inches	DO NOT EAT	2 meals/month				
Flathead catfish	DO NOT EAT	1 meal/month				
Gar (all species)	DO NOT EAT	1 meal/month				
Largemouth bass > 16 inches	DO NOT EAT	2 meals/month				
Smallmouth buffalo	DO NOT EAT	DO NOT EAT				
Spotted bass > 16 inches	DO NOT EAT	2 meals/month

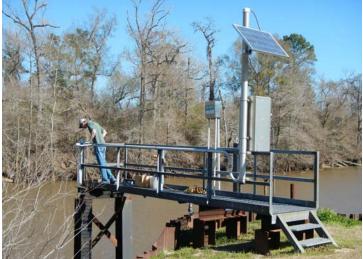
Real-Time Monitoring Station on Pine Island Bayou (CAMS 749)

Pine Island Bayou Continuous Water Quality Monitoring Project, 6/10/2008–present; CWQMN Station 749 is operated by LNVA. Real-time water quality parameters include Sample Depth, Surface Water Temperature, Specific Conductance, Turbidity, Total Dissolved Solids, Dissolved Oxygen, and pH.

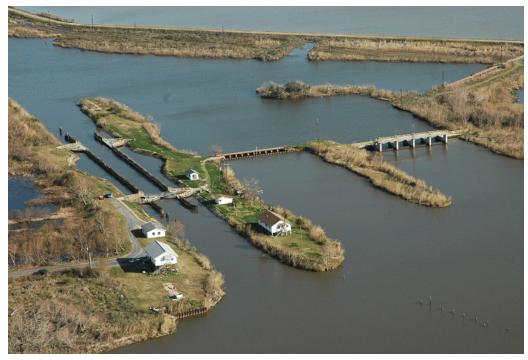
Saltwater barriers and navigational locks at the Sabine-Neches Navigation District's Taylor Bayou facility control saltwater intrusion in Taylor and Hillebrandt Bayous from the Intracoastal Waterway. (photo provided by SNND)
